Summary: HIRDLS Unverified Failures

MISSION SUCCESS REVIEW QUESTIONS FOR UNVERIFIED FAILURES

Program HIRDLS Spacecraft EOS Subsystem CSS Box CCU

Title: CCU Caging Circuit Relay

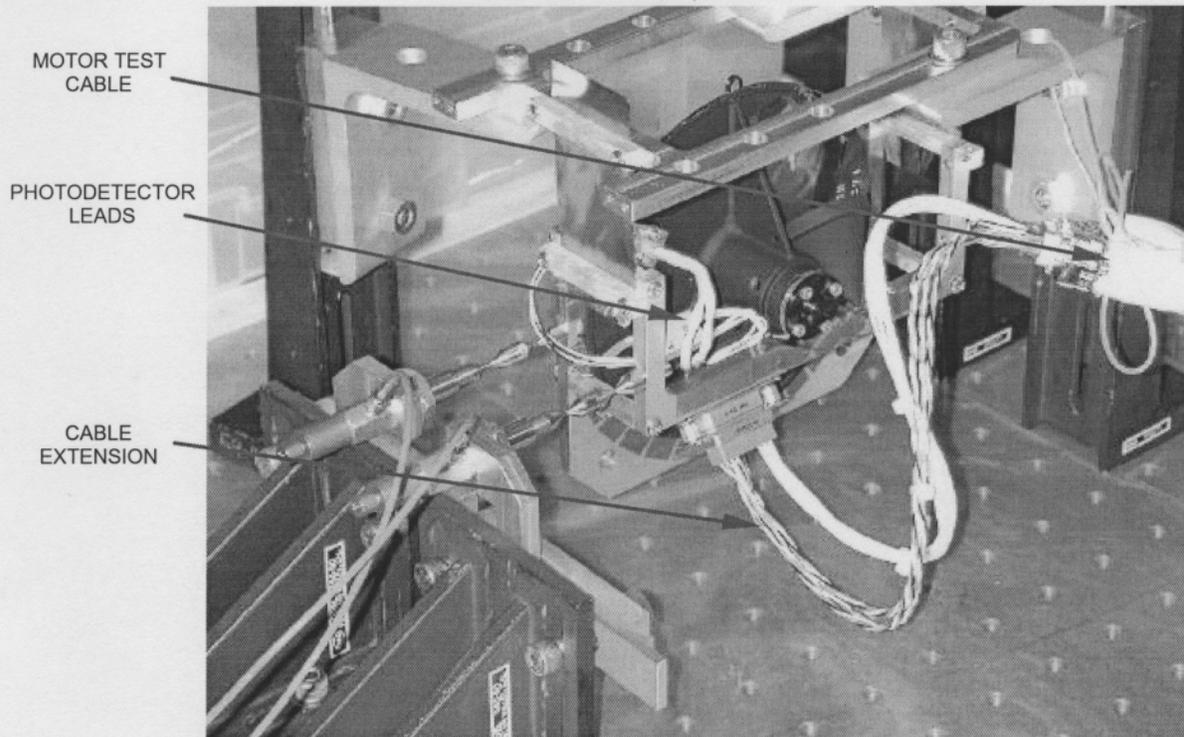
Figure 1. Chopper in balancing fixture showing photodetector leads near cradle at the point at which leads enter connector.

1b. What was the most likely cause of the anomaly? Is there a fishbone analysis, fault tree or similar analysis performed as part of the trouble shooting? Have all other suspect causes been eliminated? The most likely cause of the anomaly is that one or more contacts on the photodetector leads were not fully seated in the connector shell (per SO-LOC-0143-0060). Loose contacts would cause the low-current photodetector signal to be susceptible to noise, presenting the controller with excess signal transitions. Excess transitions would appear to the controller as an over-speed condition, causing the controller to reduce current, slowing the chopper, as observed. The anomaly was only noted for a short time following initial motor assembly, and ceased when photodetector leads were adjusted near the connector shell, which may correlate with seating of the contacts.

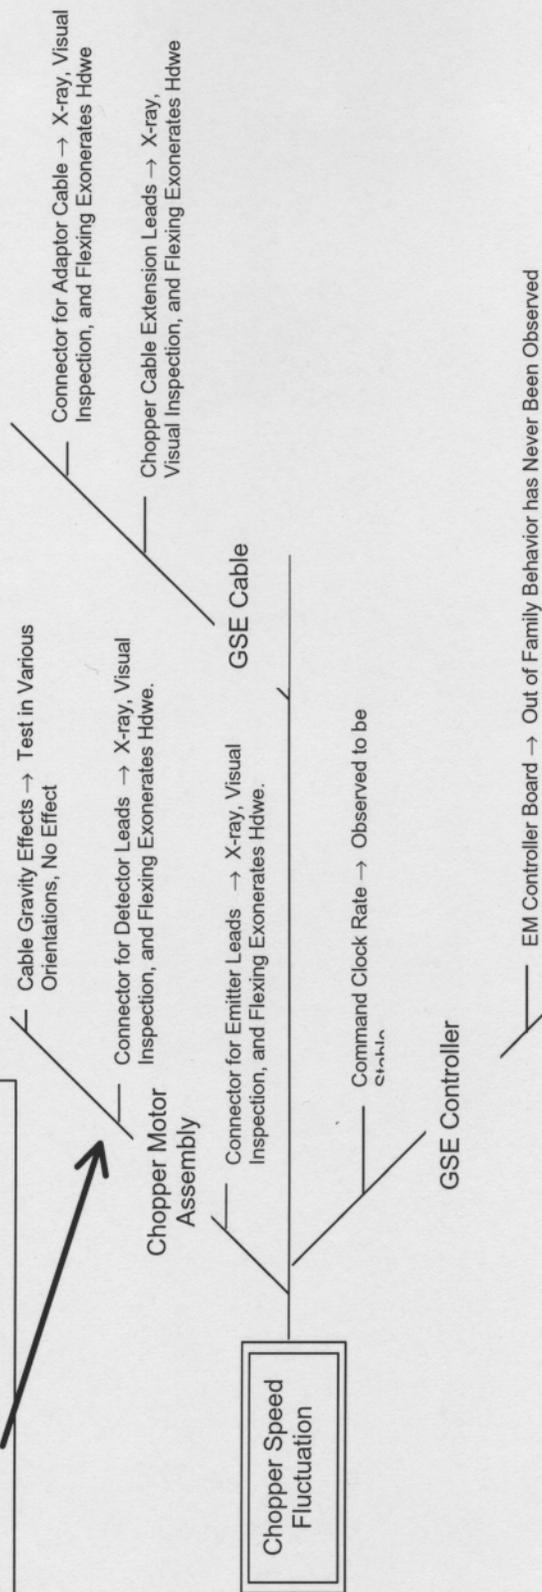
Most Likely Cause Identified as improperly seated pins in connector for detector leads, flexing of cable allowed pins to snap into place. Anomaly is not repeatable because "pins snapping into place" is an irreversible process.

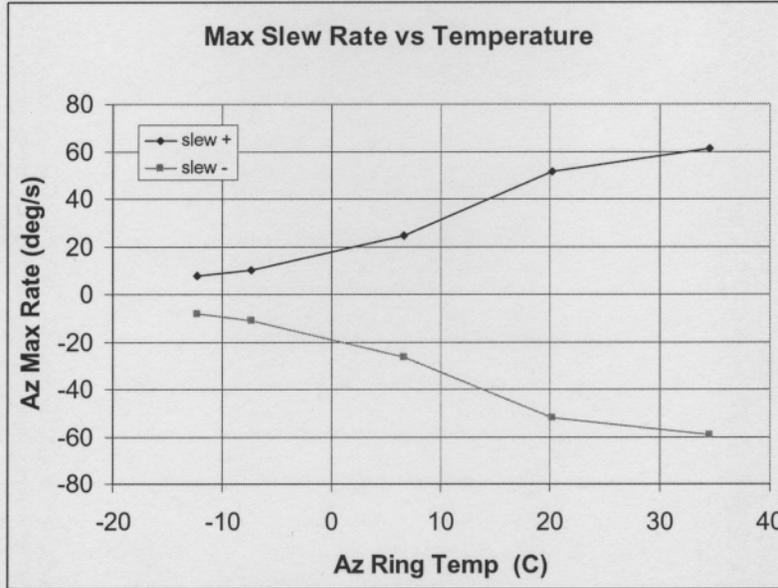
Figure 1 Slew rate vs temp. Temp cycle -12 to +35 then back to ambient. The 20 C data was from the final ambient temperature.

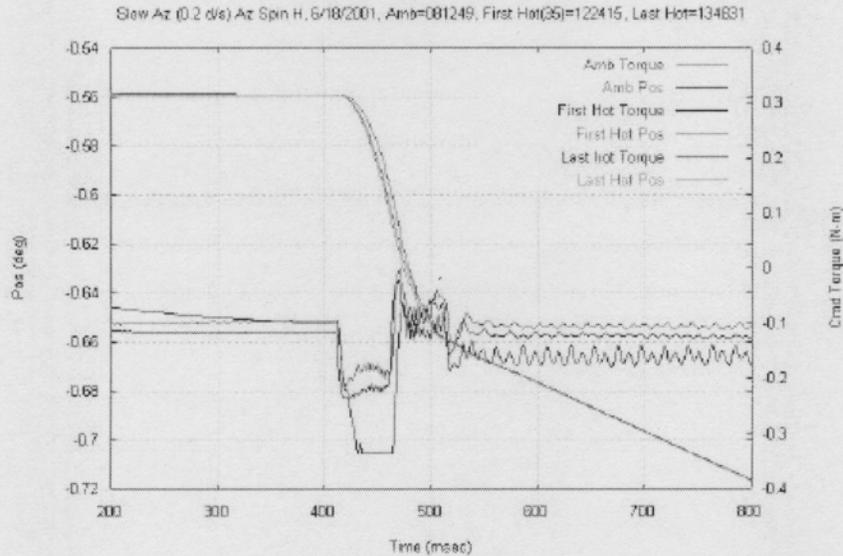
Figure 2 Slow az (0.2 deg/s +/- 2 deg). Hot result is after starting at 0,0 while ramping from ambient to hot. This plot shows torque required for the initial move at hot compared to ambient and later hot move.

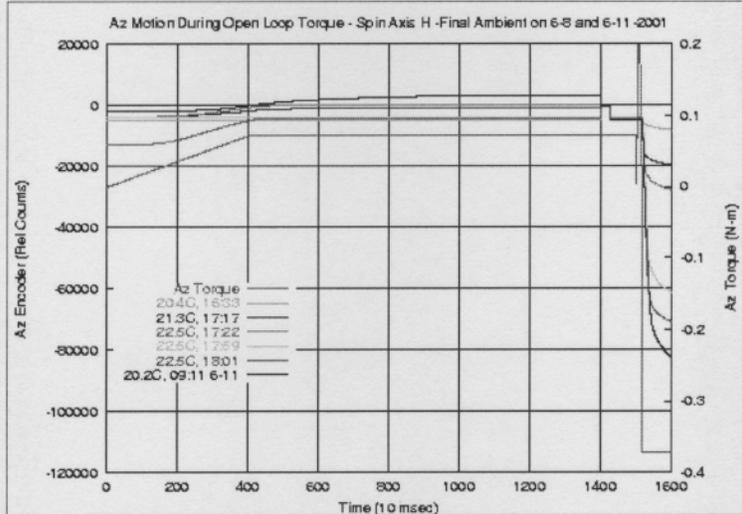
Figure 3 Azimuth motion for encoder inits at third anomaly – final ambient. This time the mirror required multiple pulses (full torque for 100 sec, followed by torque from gravity only). Twelve attempts made on 6-8-01. Mirror finally moved on the second attempt on 6-11-01.

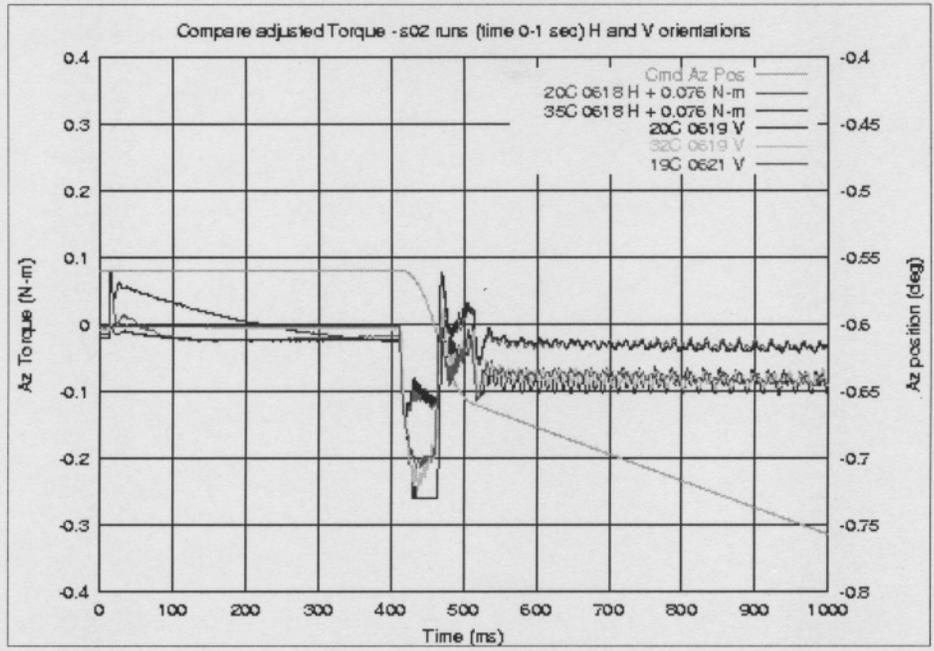
Figure 4 Test A analysis comparing H and V results following lower temperature to warmer temperature cycle with an offset applied to H torque to compensate for gravity effect.

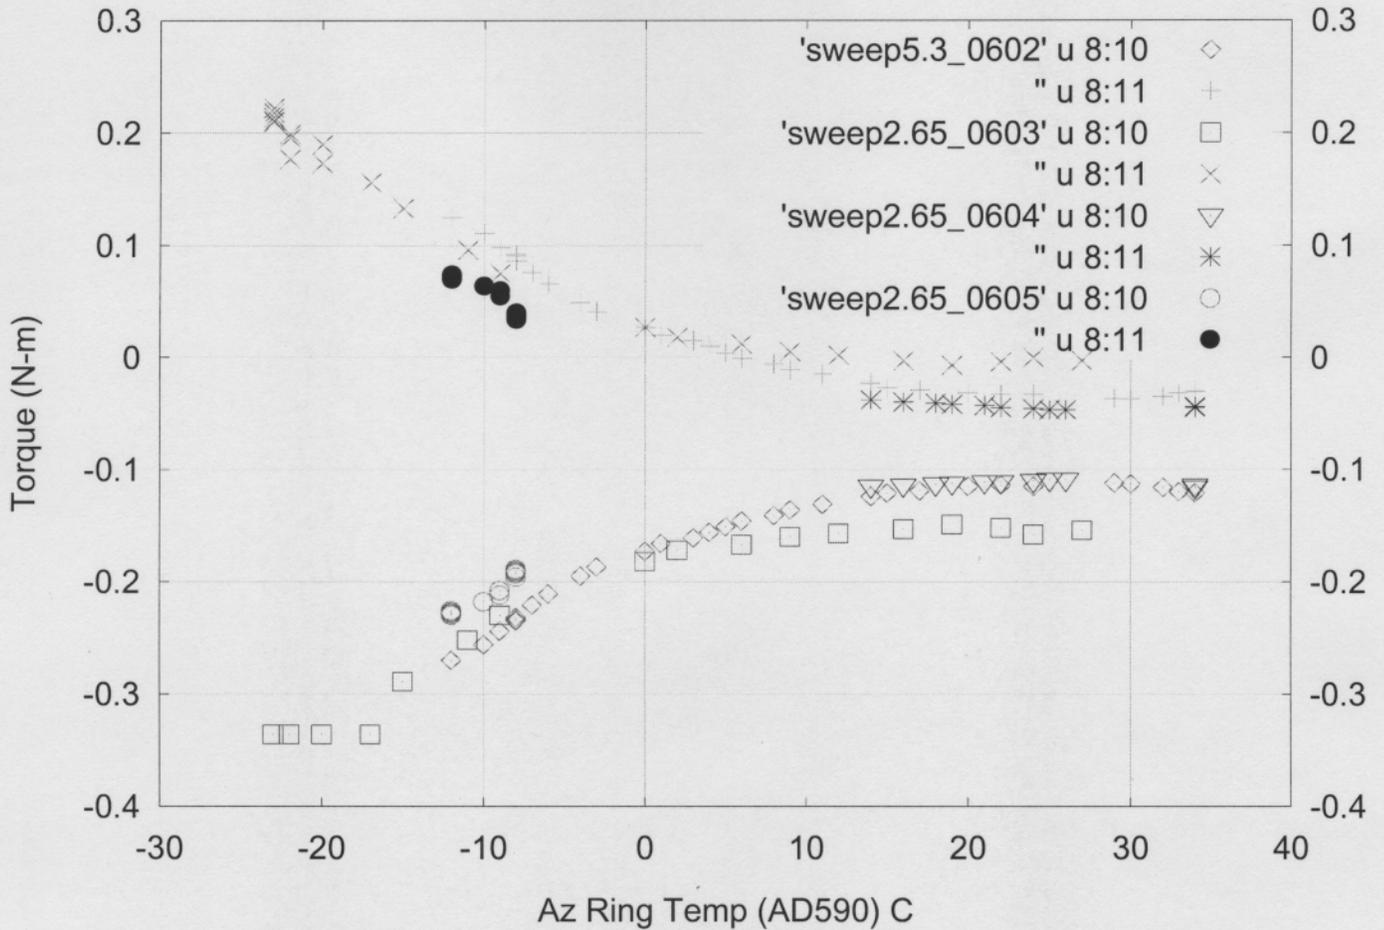
Mean Torque in Constant Velocity Portion of Range Sweep

Figure 5 Torque data from all range sweep data taken during temperature cycling. This is the torque required to maintain a constant velocity once a constant rate has been achieved. (The 0603 cold data starts out with the negative torque limit of -0.335 N-m)
