DELTA PRE-SHIP REVIEW REQUEST FOR ACTION NO. 1

Project: **EOS**
Spacecraft/Observatory: **Aura**
Instrument: **HIRDLS**

REVIEW **Delta Pre-Ship Review**
Date: **21 November 2002**

SUBJECT: HIRDLS Delta Pre-Ship Review (DPSR) RFA #5 Response

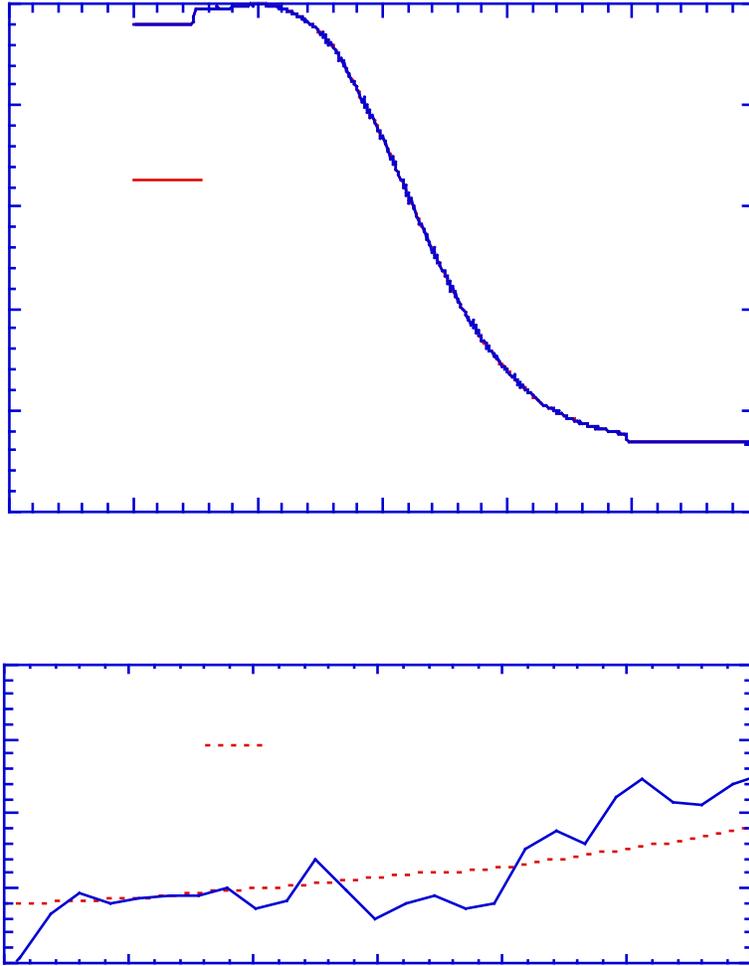
Therefore the fractional error term is just $B^{-1}(z)(\beta^2/4)d^2B/dz^2$. Since $d^2 \ln(B)/dz^2 \sim (1/H)^2$, where H is the scale height, we have that the fractional error in the radiance is $\sim(\beta/2H)^2$. For $\beta = 50$ meters and $H = 6$ km, this has a numerical value of 1.7×10^{-5} , totally negligible in relation to our required precision of 0.5%. Thus in the global mode, the jitter would have to reach 1200 meters p-p, or 80 arcsec p-p, to make an error of 0.25% in the measured radiance, the level at which it would begin to have an impact on the science.

To verify these calculations, we have run simulations with the HIRDLS Radiometric Model (HIRAM). We used channel 2, one of the temperature sounding channels, because these have the highest precision requirements. We simulated the generation of the measured radiance profile at global scan rate for the standard HIRDLS fiducial radiance profile, using specified detector noise and no jitter; then we ran the simulation again with a jitter term added to the pointing with a p-p amplitude of 140 arcsec p-p, a factor of 28 greater than observed at Oxford, so that the offset errors, 780 times larger than for 5 arcsec, as indicated above, would be large enough to see. The difference in the simulated measurements is shown, along with the radiance profile in Fig. 1. Note that as expected, the effect, as a percent of signal, is largest at the altitude where the radiance profile is changing most rapidly. The error is about 0.45% at 53 km. Scaling the result to 5 arcsec of jitter, the error is 0.0006% of the signal at an altitude of 53 km; this error is only 0.01% of the measured radiometric noise. Both of these values have a negligible science impact.

Figure 1. Simulations of the effect of 2.2 km p-p jitter at 39 Hz on the retrieved radiance profile in Channel 2. Simulations were performed using HIRAM (HIRDLS Radiometric Model). The lower panel shows a magnified view of the fractional error near the top of the scan where the error is largest, along with the values calculated from the equations above.

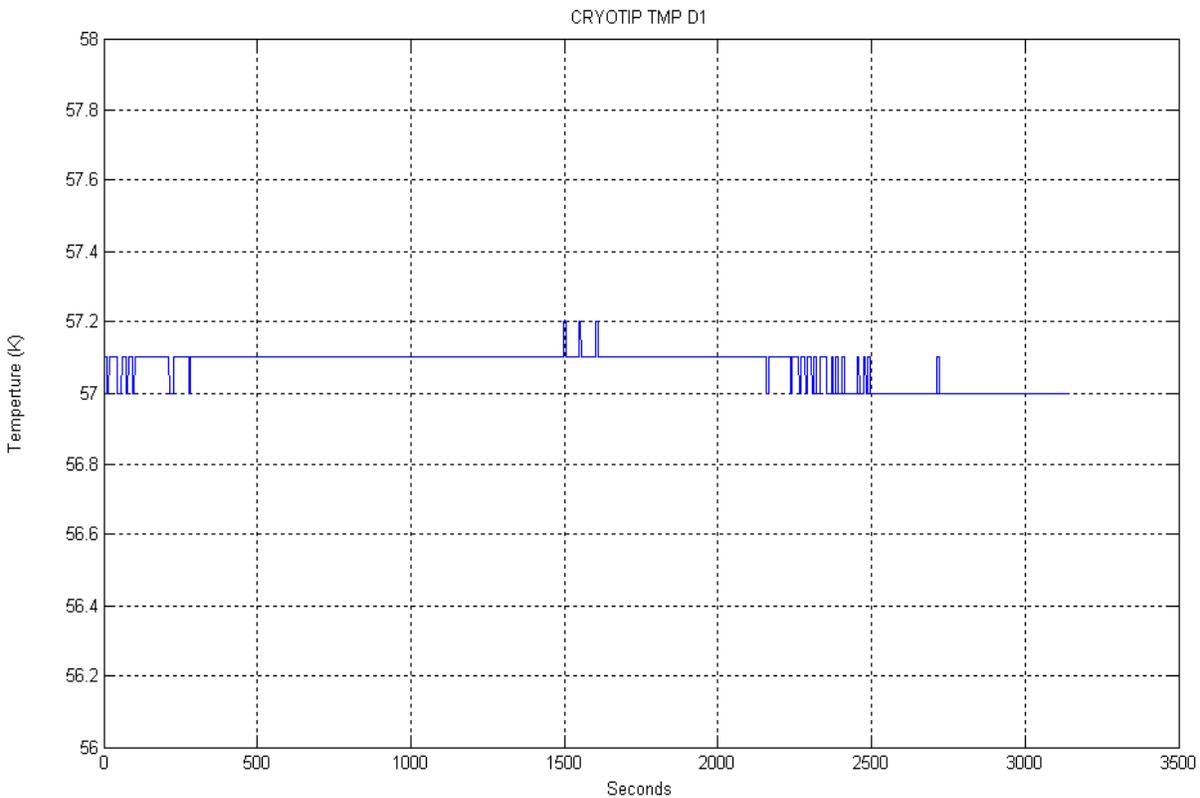
The graph below shows the cryotip temperature as sensed by D1 over a 53 minute period on day 2002_310; the cooler stroke was manually set to a constant value over this period. Note that the cryotip temperature remained constant over this period to within \pm one quantization level (0.1 K), which is as good as can be achieved with CCU closed loop control.

Use as is with the D1 sensor channel as primary and with appropriate operational workarounds in hand should the D1 channel fail in flight.

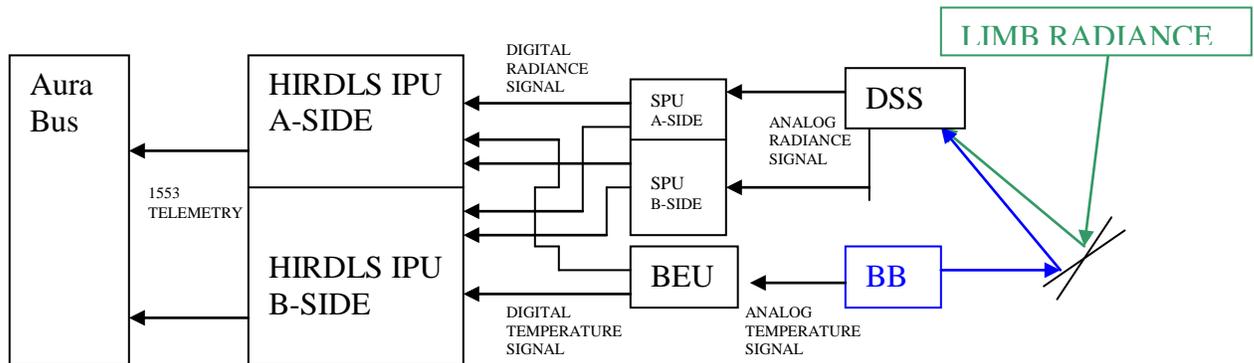
Figure X. Instrument Photon-to-Analog-to-Digital Flow Schematic. The SPU is cross strapped to both sides of the instrument, but the BEU is not. A scanning system (not shown) alternates the DSS field-of-view between the Limb, space and the on-board BB.

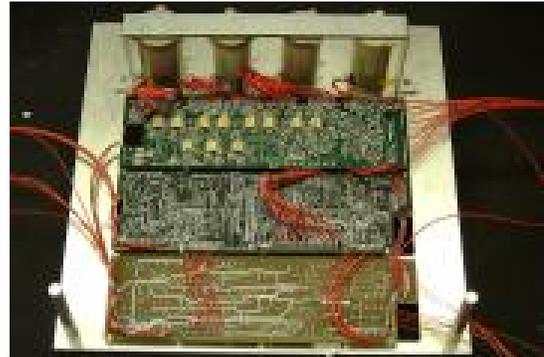
Figure X. Single Side of BEU Electronics On Assembly Fixture Before Folding. Assembly requires careful folding of analog wiring between boards and inductors.

Through that process, any number of problems could arise (damage to the wiring) affecting impedance, continuity, which could manifest as a missing bit over the range of the bridge for example. The interior of the BEU is very tight and the analog wiring is very sensitive (see Figure X and Figure X). The BEU-BB cable is most fragile and it's impedance could change with poor handling.

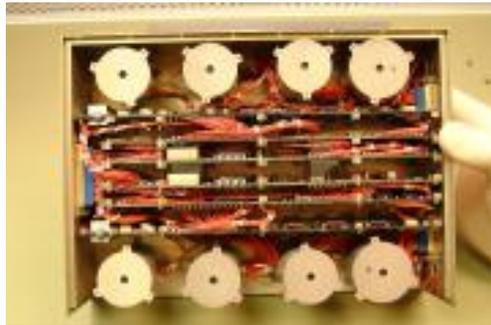
While investigations to date on flight spare hardware have confirmed a possible design feature that explains part of the anomaly, there are still anomaly instances that cannot be explained. Even after opening the BEU, there is no guarantee that a root cause could be found without invalidating the calibration effort.

Figure X. Top-Down View of BEU After Assembly. Top cover of BEU secures inductor cans in-place.

The HIRDLS Team conclusion is the risk to the Mission Success from the current anomaly is less than that due to trying to investigate to find root cause and correcting it.
